Case Study: Concave slope on outer batter of TSF C at Wiluna Gold Mine

Summary

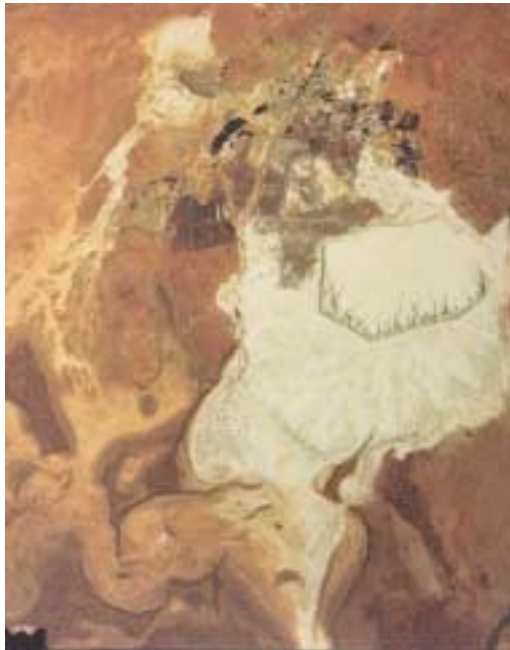
Figure 1: Aerial view of old Wiluna TSF and eroded tailings prior to placement in TSF C

The original TSF at the Wiluna Gold Mine (WA) was decommissioned in the 1940's. The storage was not rehabilitated and, as a consequence, extensive erosion of tailings occurred. More recently, during the period when the mine was managed by Barrack, Asarco then Wiluna Mines, the tailings were collected, re-processed, and placed in Tailings Storage Facility C. Re-processing had been completed before

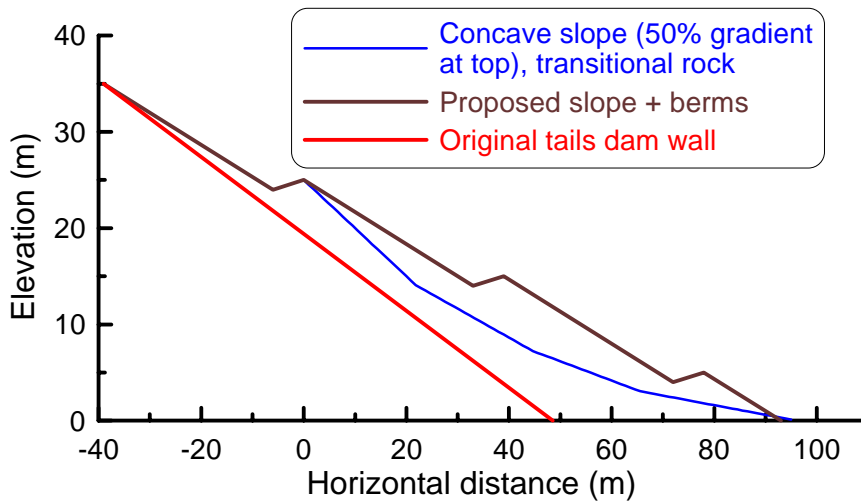
Simulations using WEPP indicated a range of slope options that could be applied. A design was developed using a 10 metre high 1:3 batter slope drained by a berm, with a 25 metre high concave slope below the berm.

Figure 2: Comparison of concave slope, original tailings dam wall, and use of berms and batters for the entire slope, Wiluna. (For convenience, horizontal distance was set at zero at the outer edge of the first berm.)

Amounts of waste rock required to construct the slope were significantly reduced (see Figure 2).

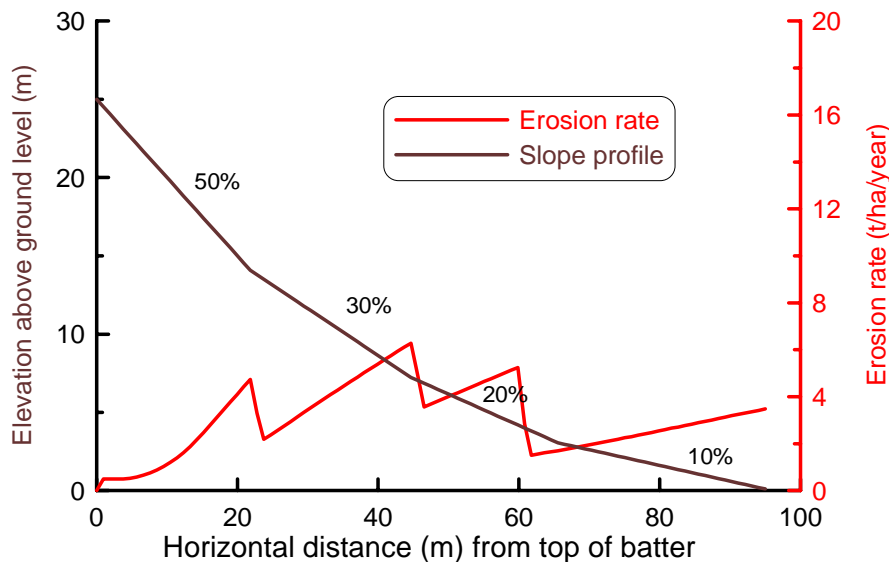
As the material most suitable for construction of the slope was the transitional rock (most plentiful, and most suitable for plant growth), simulations used that rock type. These simulations indicated that erosion rates could be expected to be <3.5 t/ha/year, with maximum erosion rates at points on the slope <6.7 t/ha/year.

Figure 3: Slope profile and predicted erosion rates along it, for transitional rock at Wiluna. Gradients of each slope segment shown.

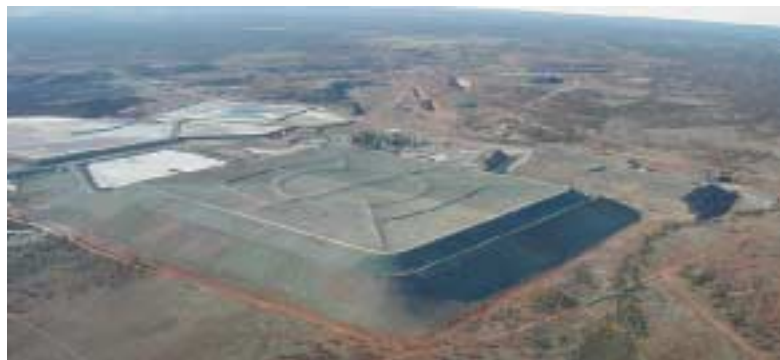
The outer batter consists, effectively, of a short (10m) linear section draining to a berm, and then a concave section (25m) stretching from the berm to ground level.

The concave section was constructed of transitional waste rock.

Figure 4: *Reconstructed Tailings Storage C .*
